Revised Update Phase I and Limited Phase II Environmental Site Assessment

REVISED UPDATE PHASE I AND LIMITED PHASE II
ENVIRONMENTAL SITE ASSESSMENT
11-ACRE PROPERTY, APN 235-202-35-00
2115 AMANDA LANE, ESCONDIDO
SAN DIEGO COUNTY, CALIFORNIA 92027

W.O. E6539-SC JULY 19, 2013

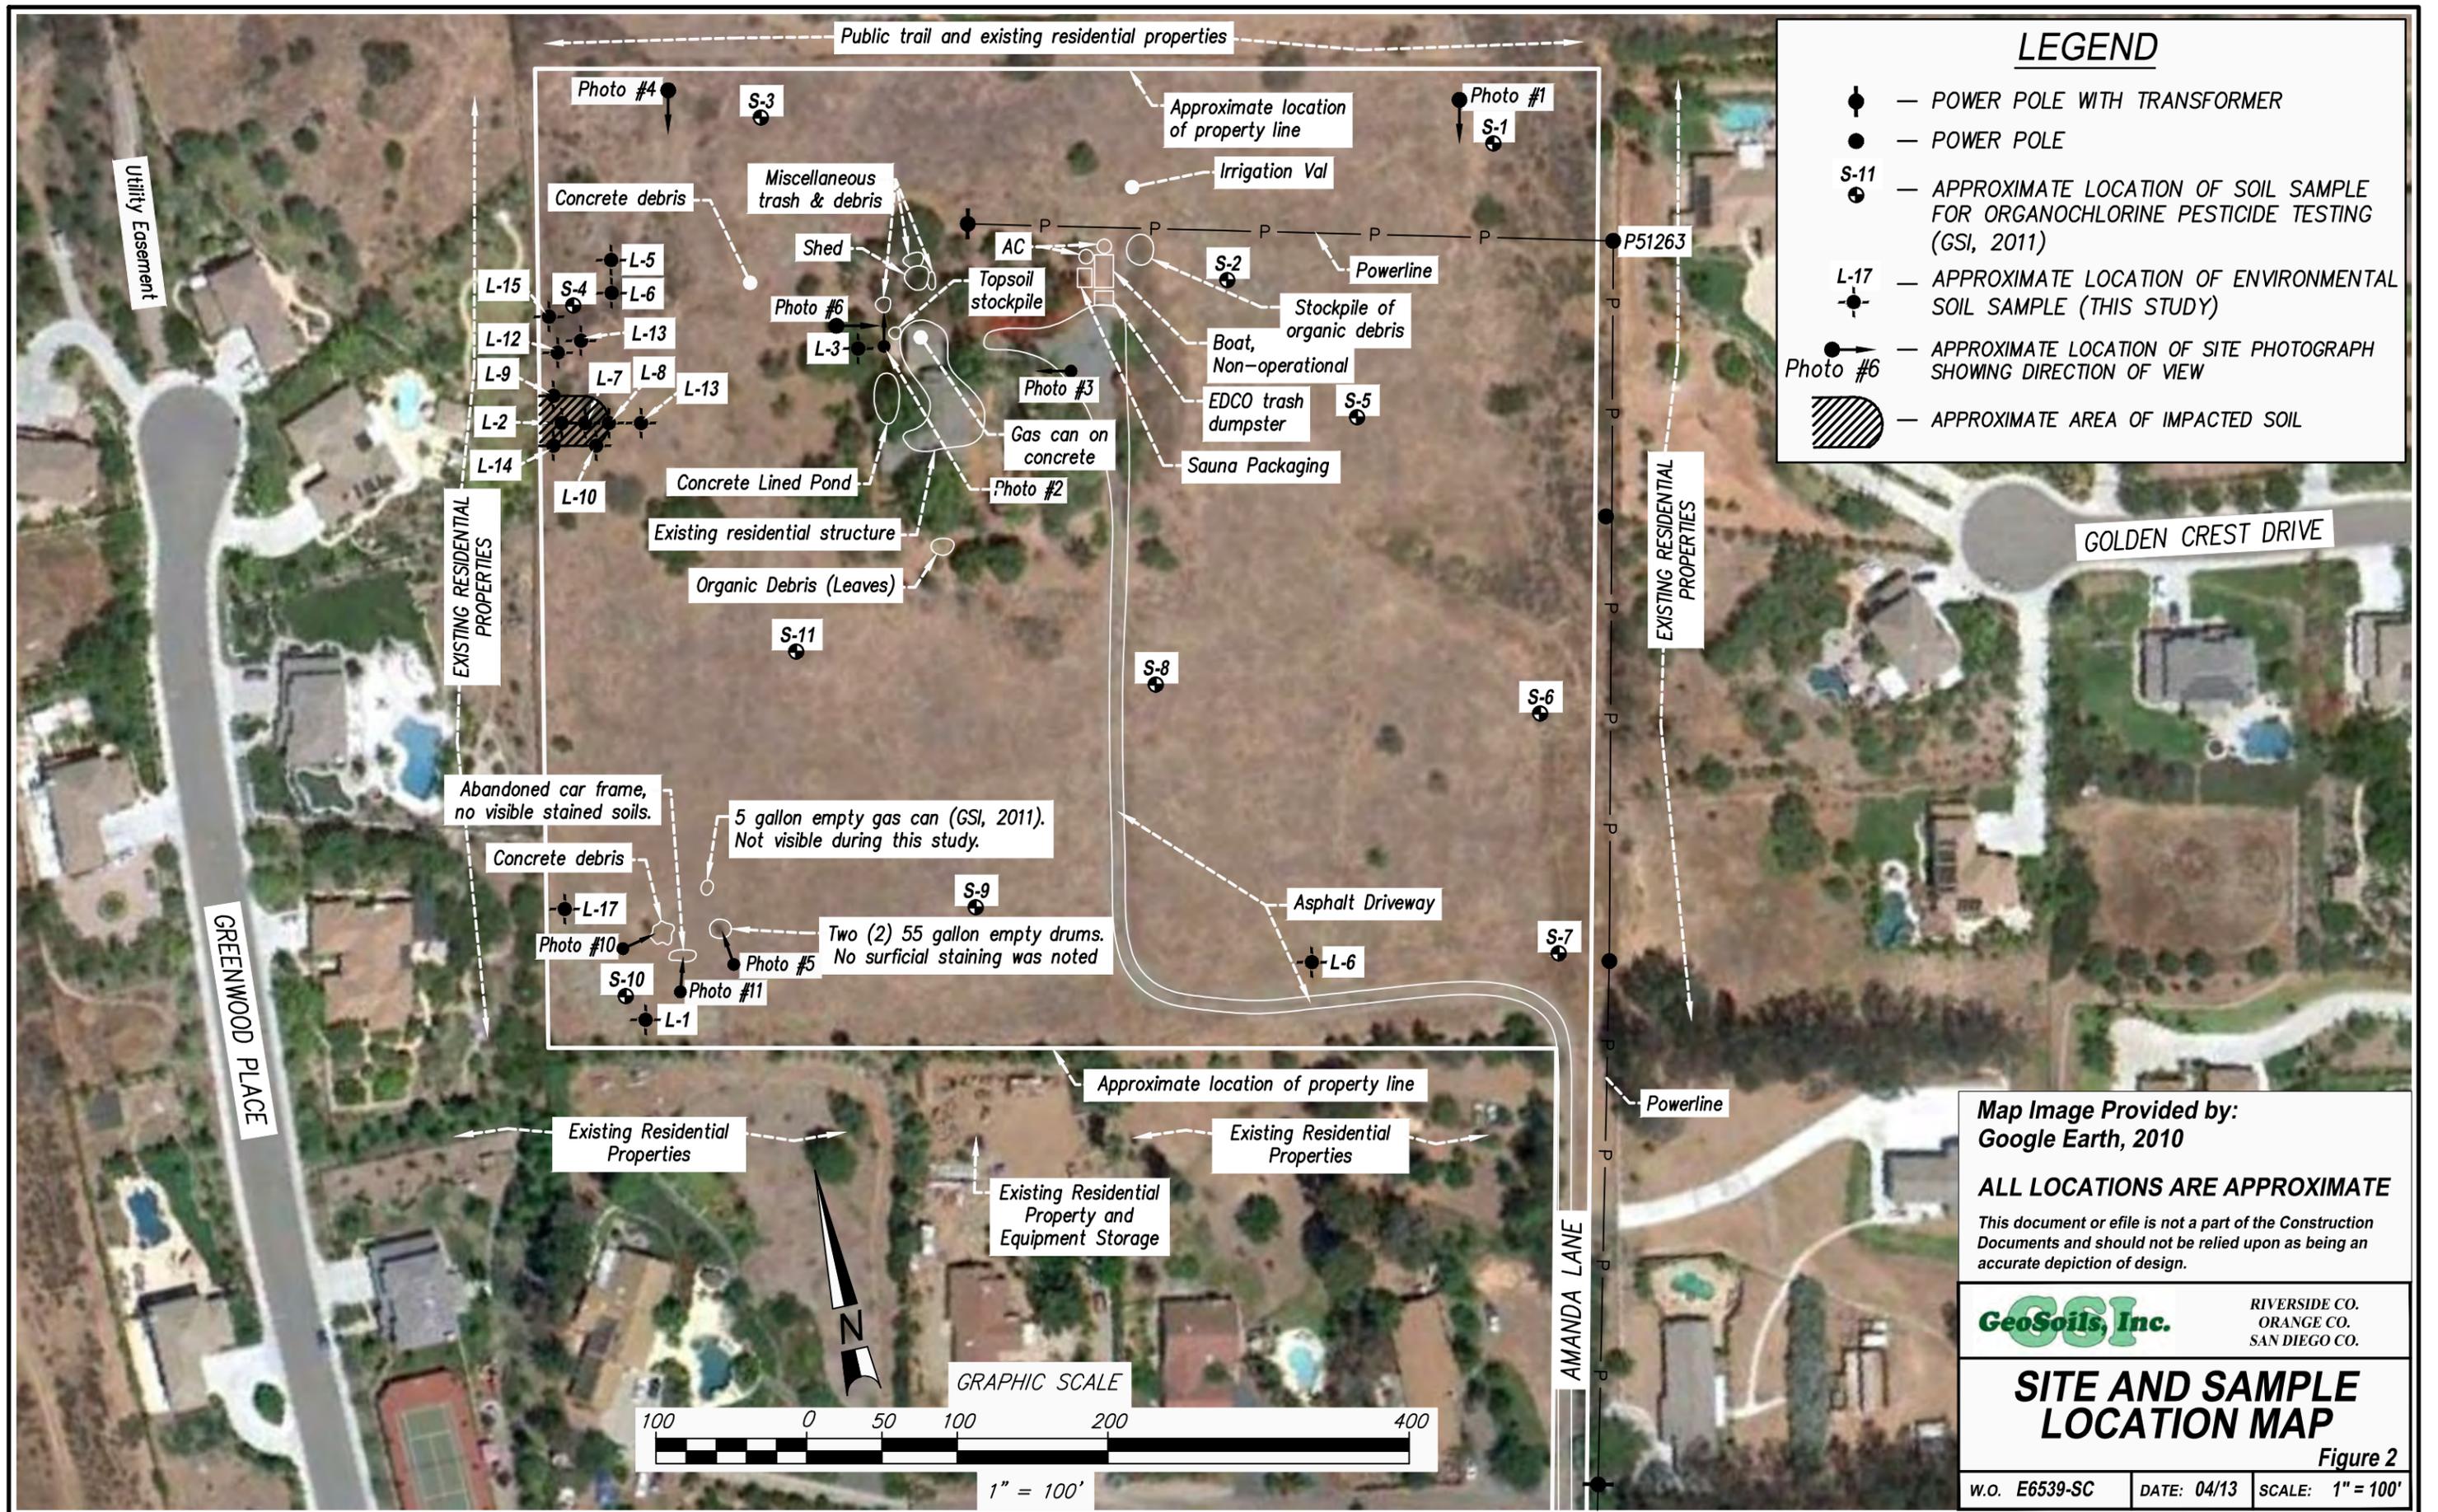
properties from the subject site. Features observed during the site reconnaissance are described below and illustrated on the Site and Sample Location Map (see Figure 2) which uses Google Earth imagery as a base. Photographs of the subject property are presented in Appendix C on the CD data disc. The photograph locations and viewpoints are also indicated on Figure 2 (Site and Sample Location Map).

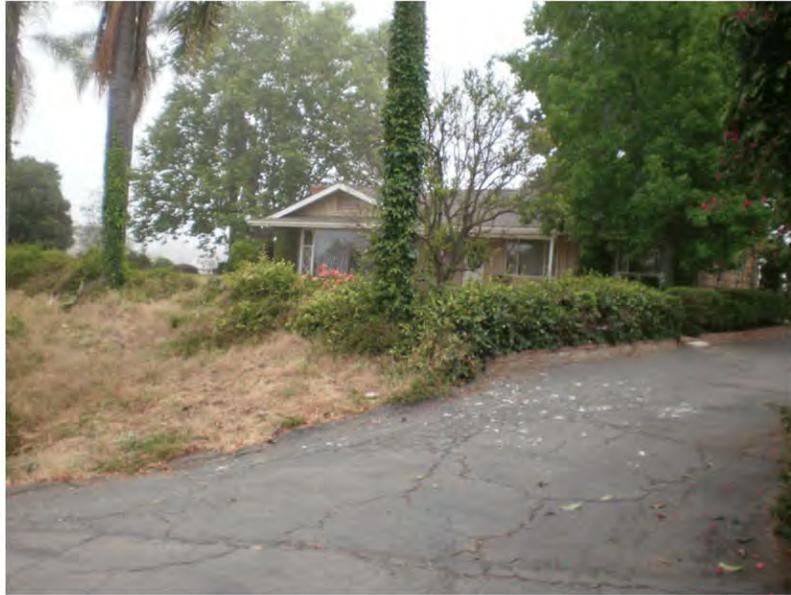
1. Photograph showing existing residential structure and driveway, typical trees, grass, and shrubs (looking northwest).

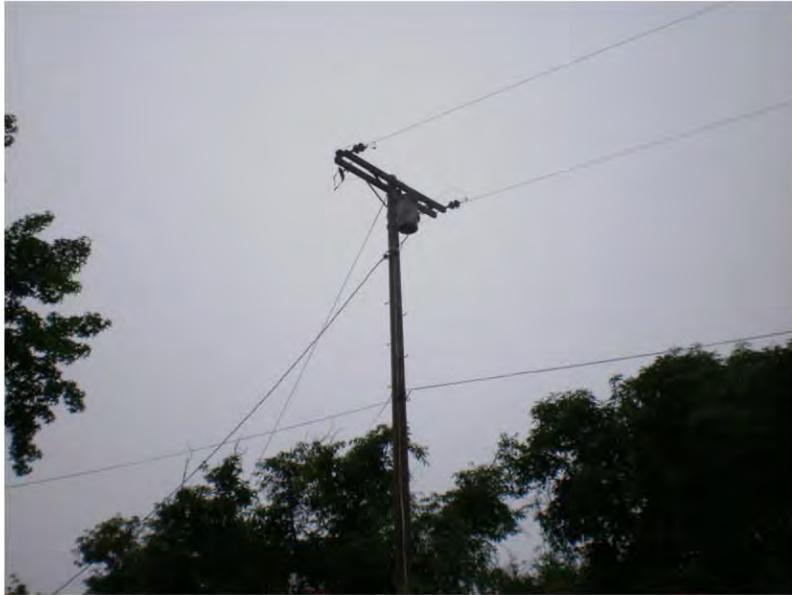
3. Power pole with transformer (looking northwest).

- **Potential Sources of Polychlorinated Biphenyls (PCBs)** - GSI observed an above-ground transformer on the wooden power pole, located north of the detached garage. The transformers appeared to be in fair to good condition and no readily visible evidence of surficial soil staining was observed on the ground beneath the transformer. Power transformers in San Diego County are typically owned and operated by San Diego Gas & Electric (SDG&E). Previous conversations with SDG&E employees have indicated that the possibility of PCB's leaking from their transformers is extremely unlikely, as the transformers are now probably filled with mineral oil. SDG&E has indicated that should the transformers leak, it should be their responsibility to perform cleanup. Given the above, PCB contamination is not considered an REC at this time.

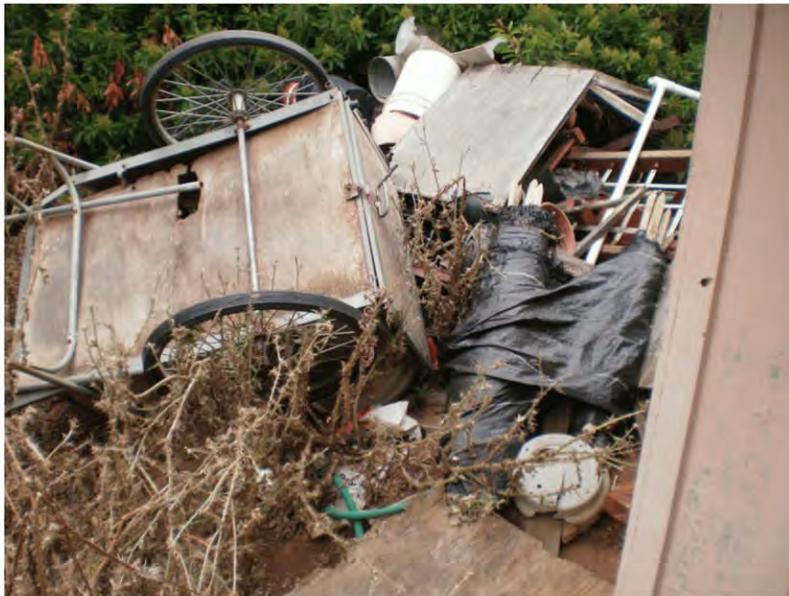
4. Typical stockpiles of wood and miscellaneous debris near the storage shed (looking north).

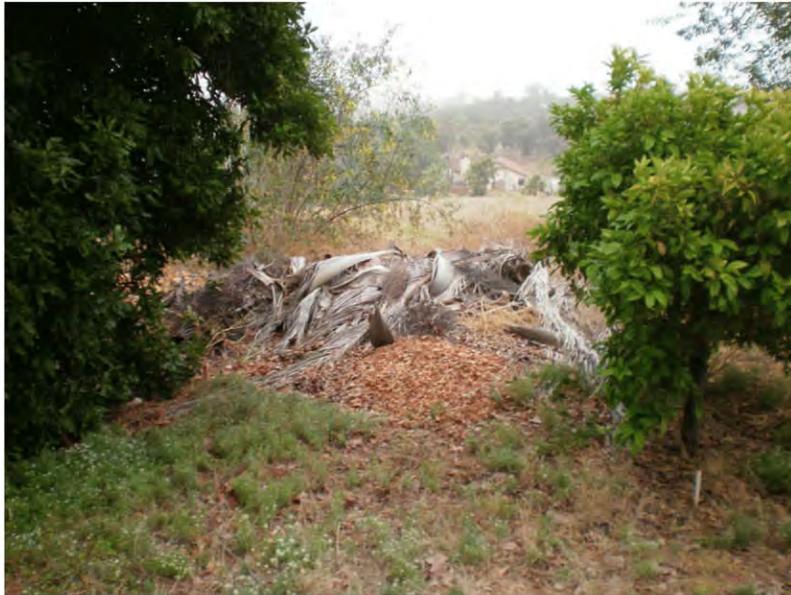
5. Typical stockpile of miscellaneous organic debris (looking south).

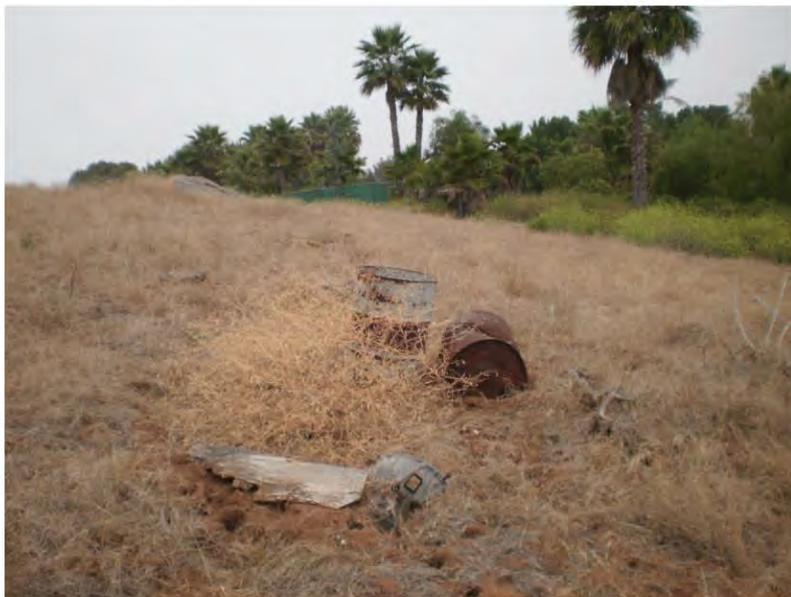
6. View of two empty 55-gallon drums (looking northeast). No significant visual surficial staining was noted in this area.

- **Drum Storage** - Two abandoned 55-gallon drums were observed near the southwest corner of the property. These drums appeared empty and no readily visible evidence of stained soils were observed in their proximity. A small plastic fuel container was observed on a concrete surface along the southern exterior wall of the garage. This container appeared to be in good shape, stored properly, and no evidence of leakage was noted. The 5-gallon empty gas can observed during GSI (2011), near the southwest corner of the property was not readily identified during our recent site reconnaissance. Drum storage is not considered an REC at this time.

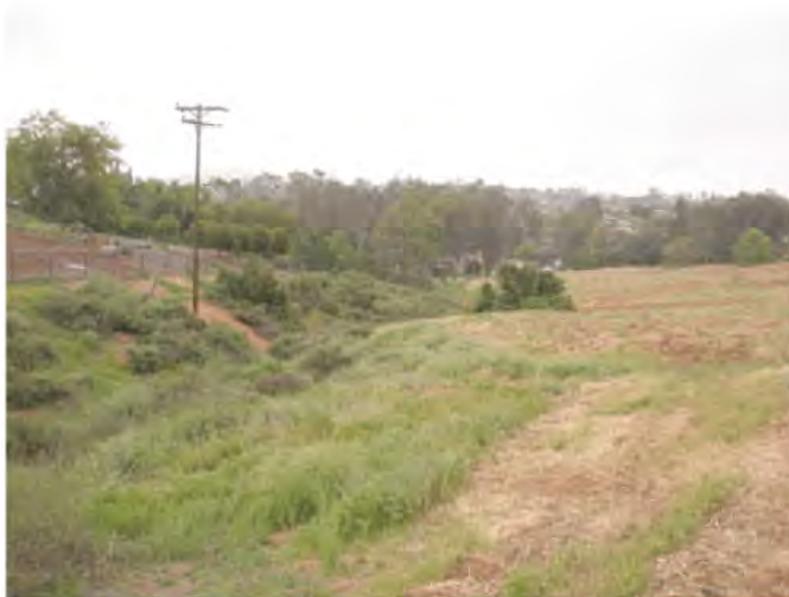
1. Photograph of the site's eastern margin. Note the overhead electrical lines to the left of the photograph and the north-to-south trending, natural drainage swale. Photographic view is to the south.

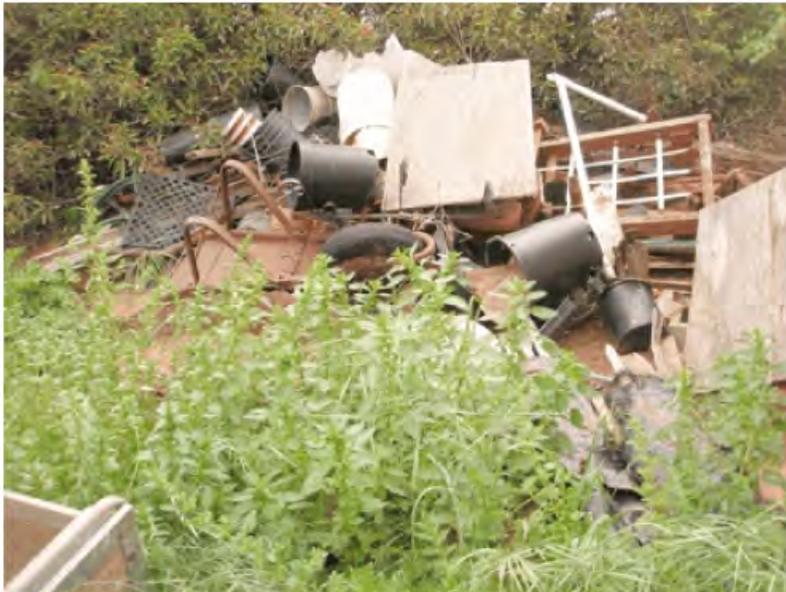
2. Photograph of stockpiled plastic planting containers, Polyvinyl Chloride (PVC) piping, and miscellaneous debris. The stockpile was not disturbed. Photographic view is to the north.

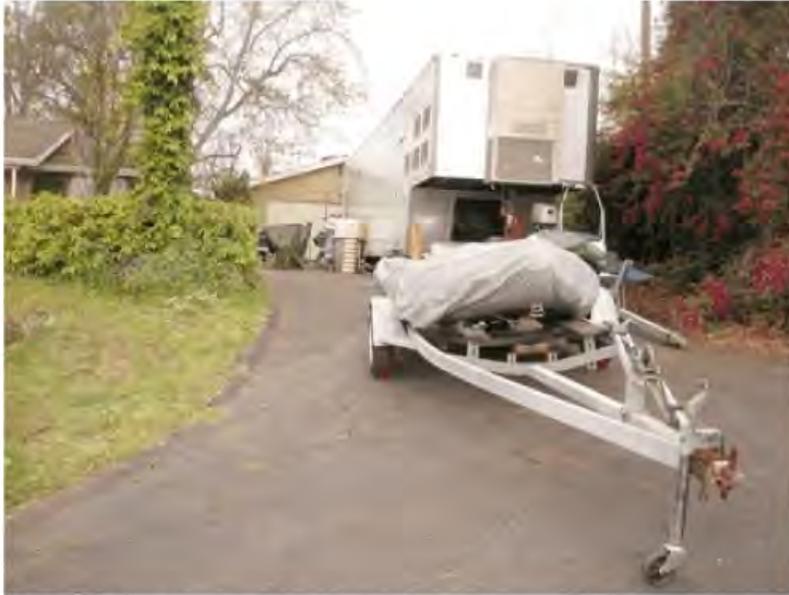
3. Photograph of detached garage, trailer, and boats. No readily visible evidence of significant petroleum or oil staining was observed on the asphaltic concrete driveway. Photographic view is to the west.

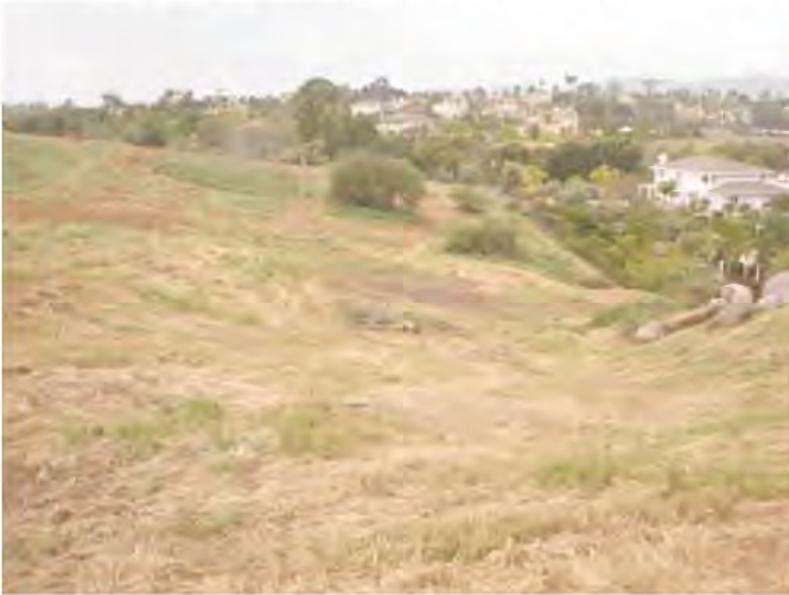
4. Photograph of the site western margin. Note the incised natural drainage swales in the middle, right of the photograph where undocumented fill was observed near the western property line. Photographic view is to the south.

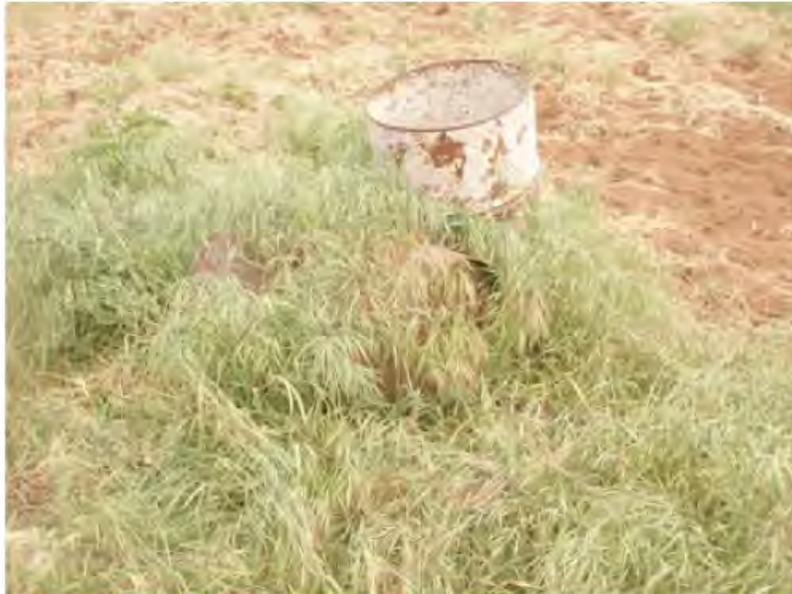
5. Photograph of two (2) empty 55-gallon metal drums. These drums appeared to be empty and no readily visible evidence of staining was observed on the surrounding soils. Photographic view is to the northwest.

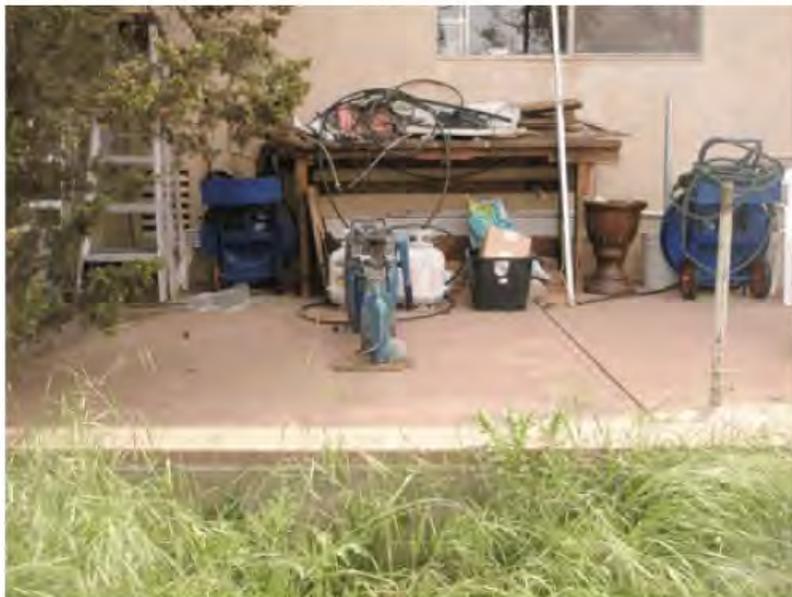
6. Photograph of the rear of the detached garage where the current tenant reportedly repairs outboard boat motors. No readily visible evidence of petroleum or oil staining was observed on the concrete patio. Photographic view is to the east.

Based on personal communication with the tenant, GSI understands that the tenant occasionally repairs outboard boat motors in the rear of the detached garage. GSI observed a small quantity plastic container of gasoline being stored on a concrete slab, along the southern exterior wall of the garage. No readily visible evidence on leakage or staining was observed where the reported motor repair occurs. The tenant indicated that lubricants and oil are disposed in a lawful manner.
