**C. Lead and Asbestos Survey by Vinje and Middleton for 301 & 309
Grand Avenue, Escondido, CA, dated September, 2018**

HAZARDOUS BUILDING MATERIALS SURVEY

301 and 309 East Grand Avenue
Escondido, California 92025

AEC Project No. 18-290SD
October 3, 2018

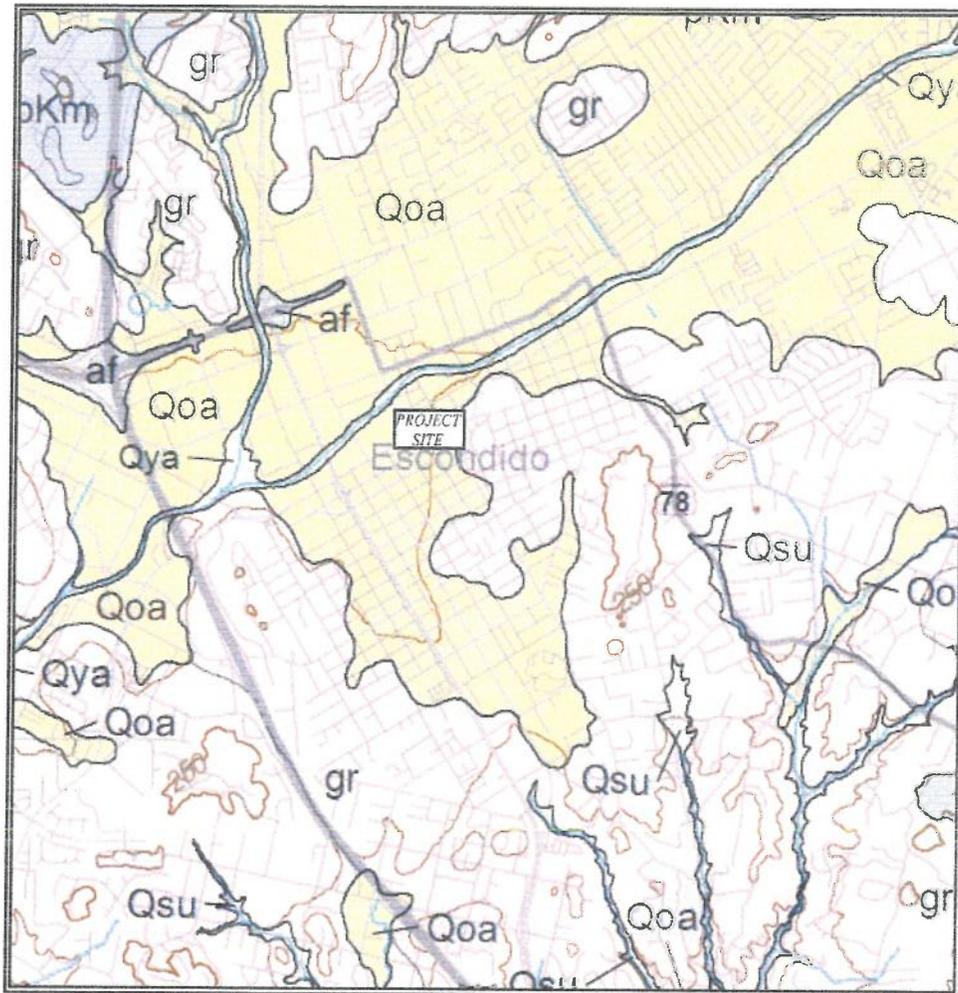
GEOLOGIC MAP
301 & 309 Grand Avenue
Escondido

Pertinent Geologic Units

Scale: 1:50,000

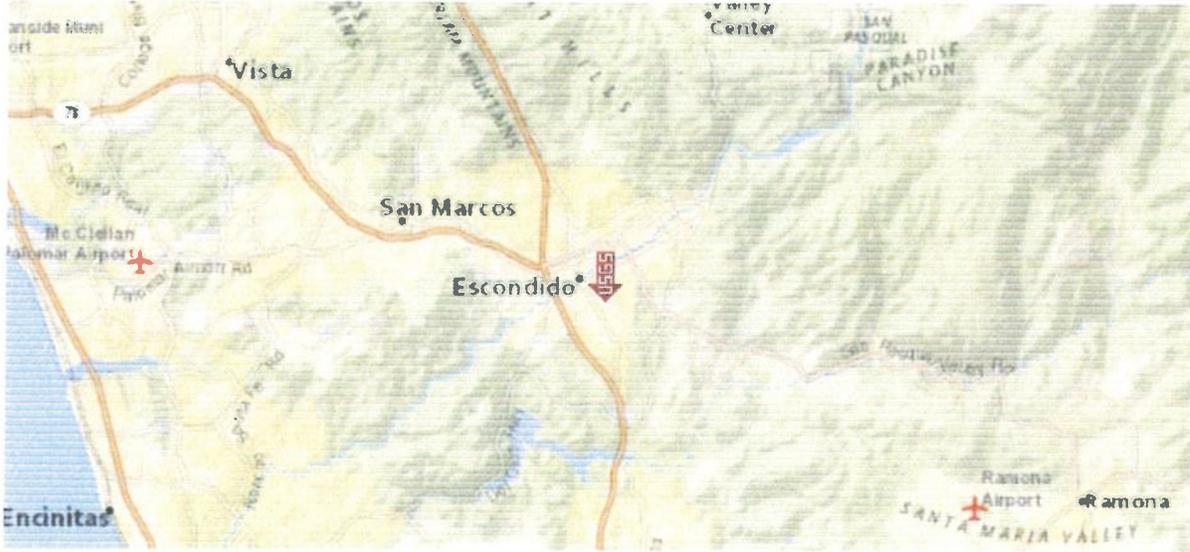
Site Soil Classification Site Class D – "Stiff Soil"

Risk Category I/II/III

USGS-Provided Output

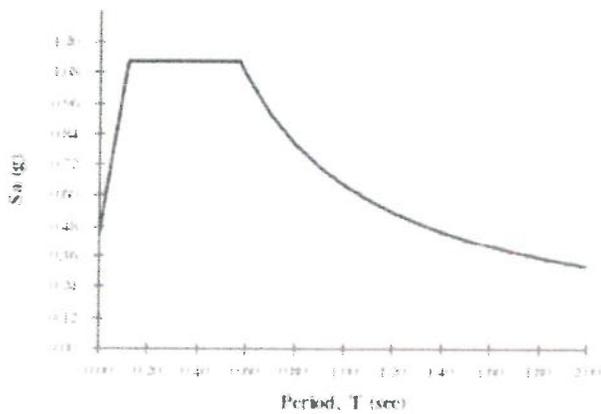
MCE_R Response Spectrum

$S_5 = 1.032 \text{ g}$	$S_{M5} = 1.122 \text{ g}$	$S_{D5} = 0.748 \text{ g}$
$S_1 = 0.399 \text{ g}$	$S_{M1} = 0.639 \text{ g}$	$S_{D1} = 0.426 \text{ g}$

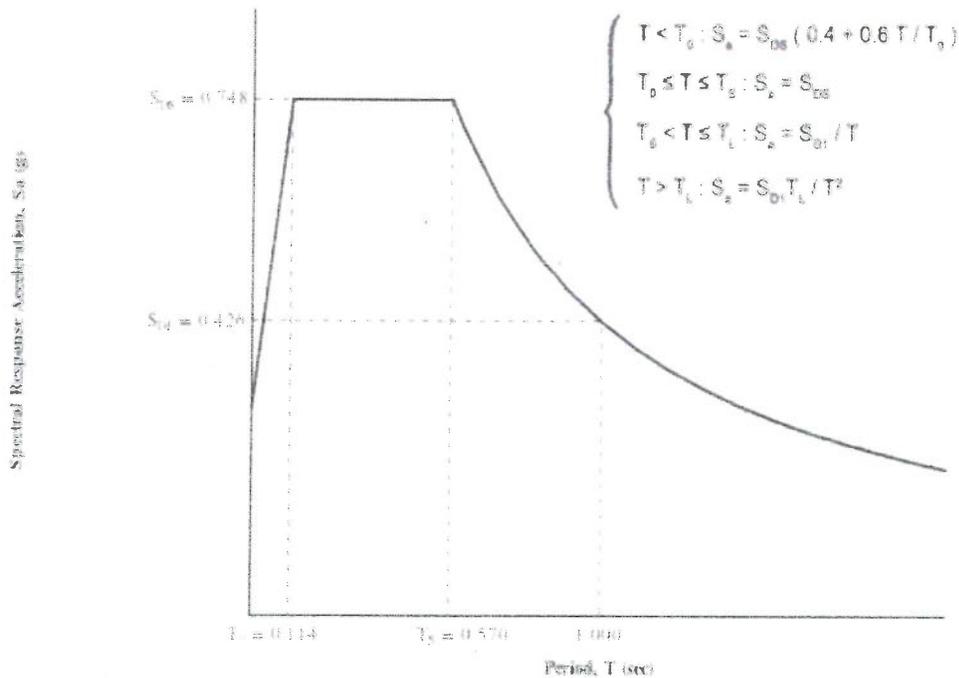
Figure 11.4-1: Design Response Spectrum

$T_L = 8$ seconds

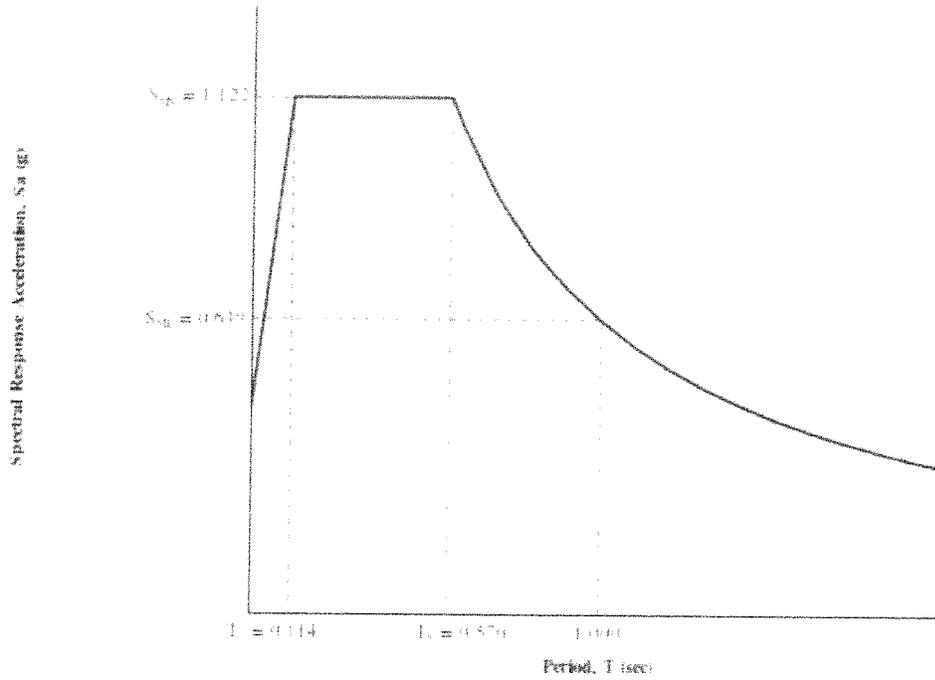
Section 11.4.6 — Risk-Targeted Maximum Considered Earthquake (MCE_R) Response Spectrum

The MCE_R Response Spectrum is determined by multiplying the design response spectrum above by 1.5.
